## EFFECT OF BROOM TEXTURE ON MOTORCYCLE RIDEABILITY

INTERIM REPORT

**CA-HY-MR3126-8-72-32**

Prepared in Cooperation with the U.S. Department of Transportation, Federal Highway Administration August, 1972

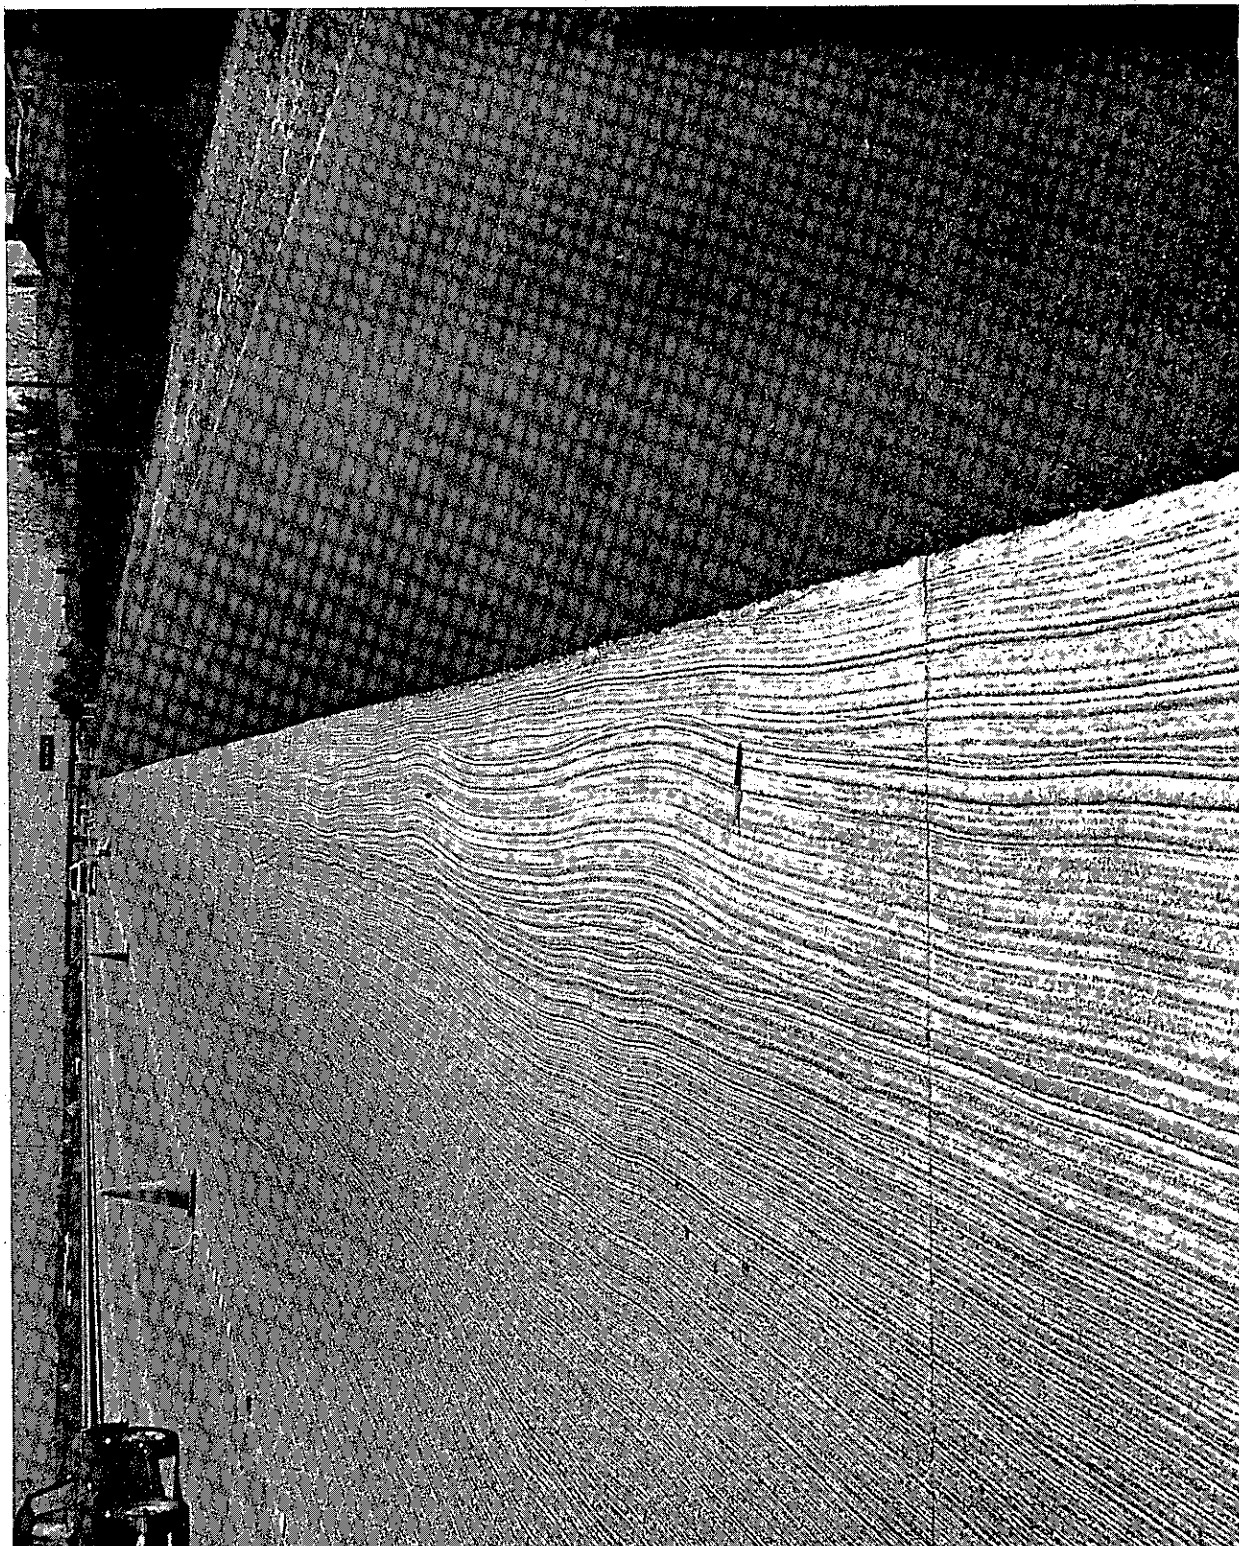
vicinity of Occidental Avenue O.C., the No. 4 (right hand) Eastbound lane was selected for concerted evaluation. This particular area had a heavy broom texture with deep wavy striations (see Figures 1 and 2) and represented a section of the more severe texture. In addition, a cursory evaluation was made of the portion of freeway from Watt Avenue to Stockton Boulevard in the outer lane, both directions.

Figure 1. Typical condition of surface texture

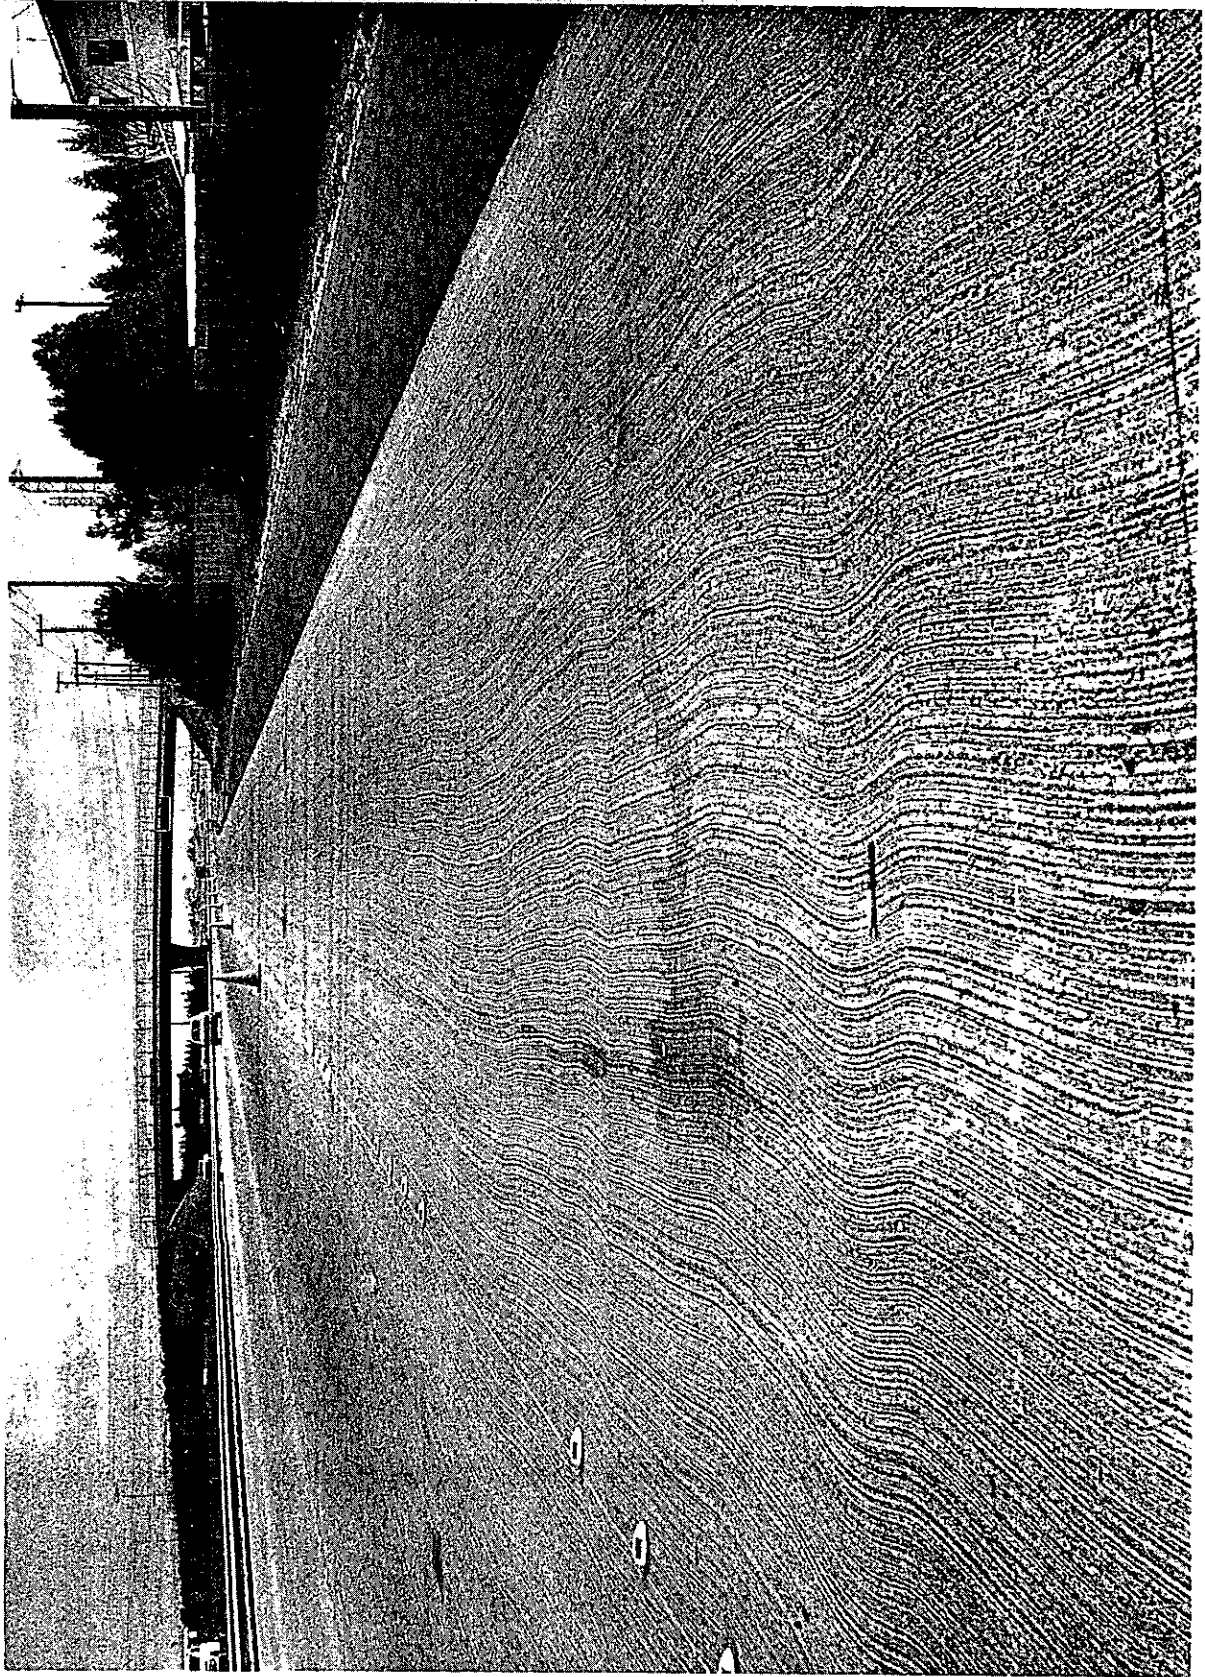
Figure 2. Typical condition of surface texture

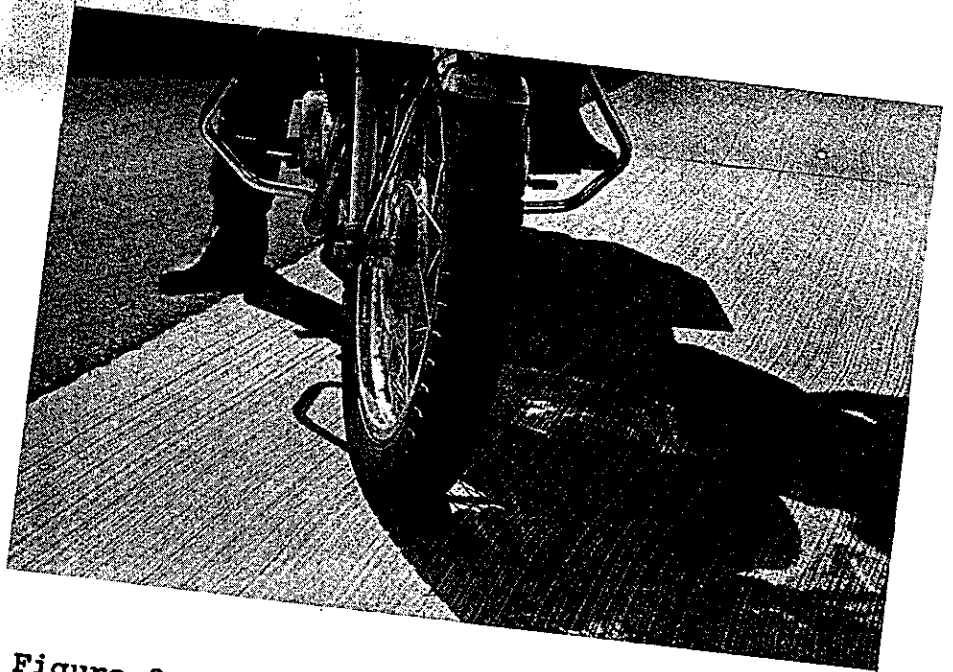
There was some slight oscillation with the semi-knobby tires on the 500 cc bike, and a moderate amount with the 250 cc bike. Although this oscillation was more apparent using the 250 cc bike, it presented no problems in controlling the machine at the test speeds.

Figure 9. 500 cc Bike with Semi-knobby Tires

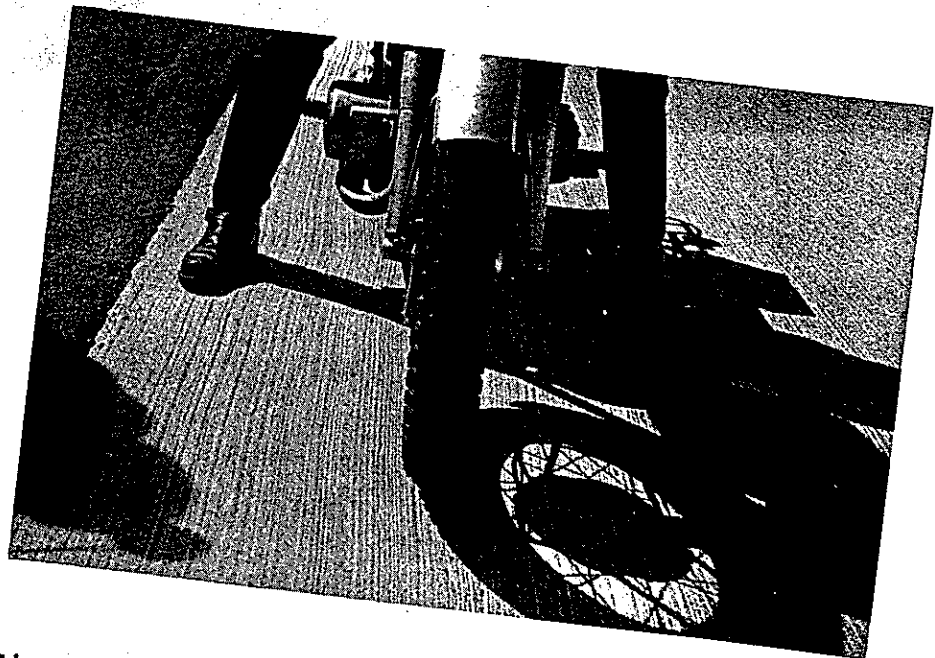
Figure 10. 250 cc Bike with Semi-knobby Tires
